City of Griffin

Hydrant Testing & Maintenance

Program

May, 2003

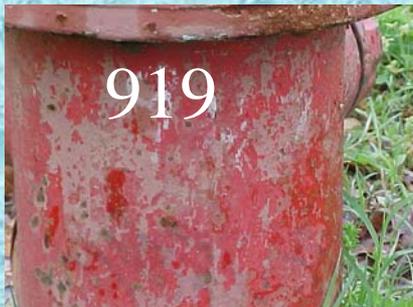
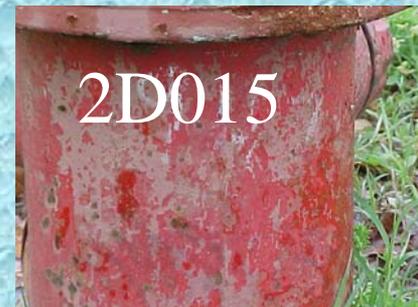
- Red spray paint will cover old number
 - Write down old number first, then spray paint over it
- New number will be located in same place
 - Under bonnet on backside of hydrant
 - Use white paint pen

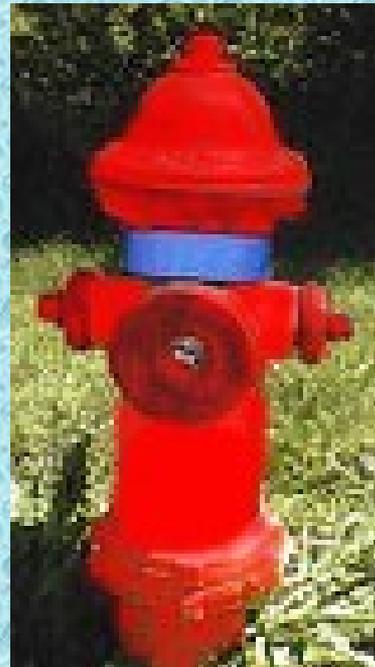
Red Bonnet

Counterclockwise rotation

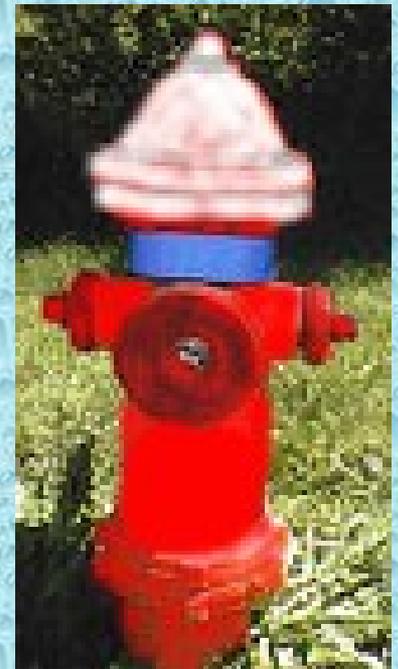
White Bonnet

Clockwise rotation
